Evaluation and Repair of Masonry Construction

Abstract – Many existing masonry buildings require repair or strengthening to address long-term deterioration effects, structural deficiencies, or concerns regarding seismic performance. This paper follows a project to retrofit an historic masonry building as a case study to present the process of evaluation and repair. Nondestructive and in-place test methods are used to evaluate existing construction to identify as-built conditions and masonry engineering properties. Load-bearing capacity of walls are then augmented by installation of internal reinforcing bars and injection of voids using a Compatible Injection Fill (CIF). Unique to this application is installation of a series of diagonal stitching bars to confine the masonry and enhance masonry compression response.

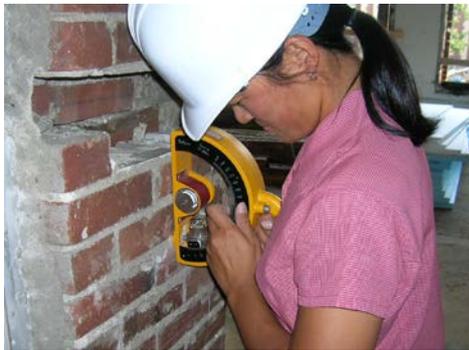
Fig. 1 Mortar rebound hardness, measured here using a pendulum hammer.

Mortar rebound hardness was used on this project to evaluate relative properties of original mortar and pointing mortar used as part of prior repairs (Fig. 1). Data from mortar rebound tests was used to specify an appropriate compatible replacement mortar and to identify locations where incompatible repair mortars were used during prior maintenance work.

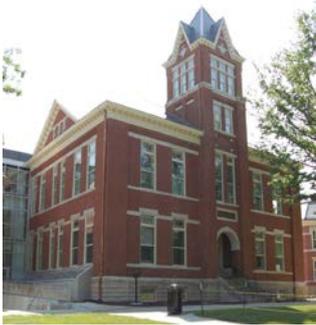
Fig. 6 The building's final appearance remained unaltered after all structural strengthening measures were completed.
